DOT/FAA/CT-94/89

Corrosion of Fire-Damaged Aircraft

April 1995

Final Report

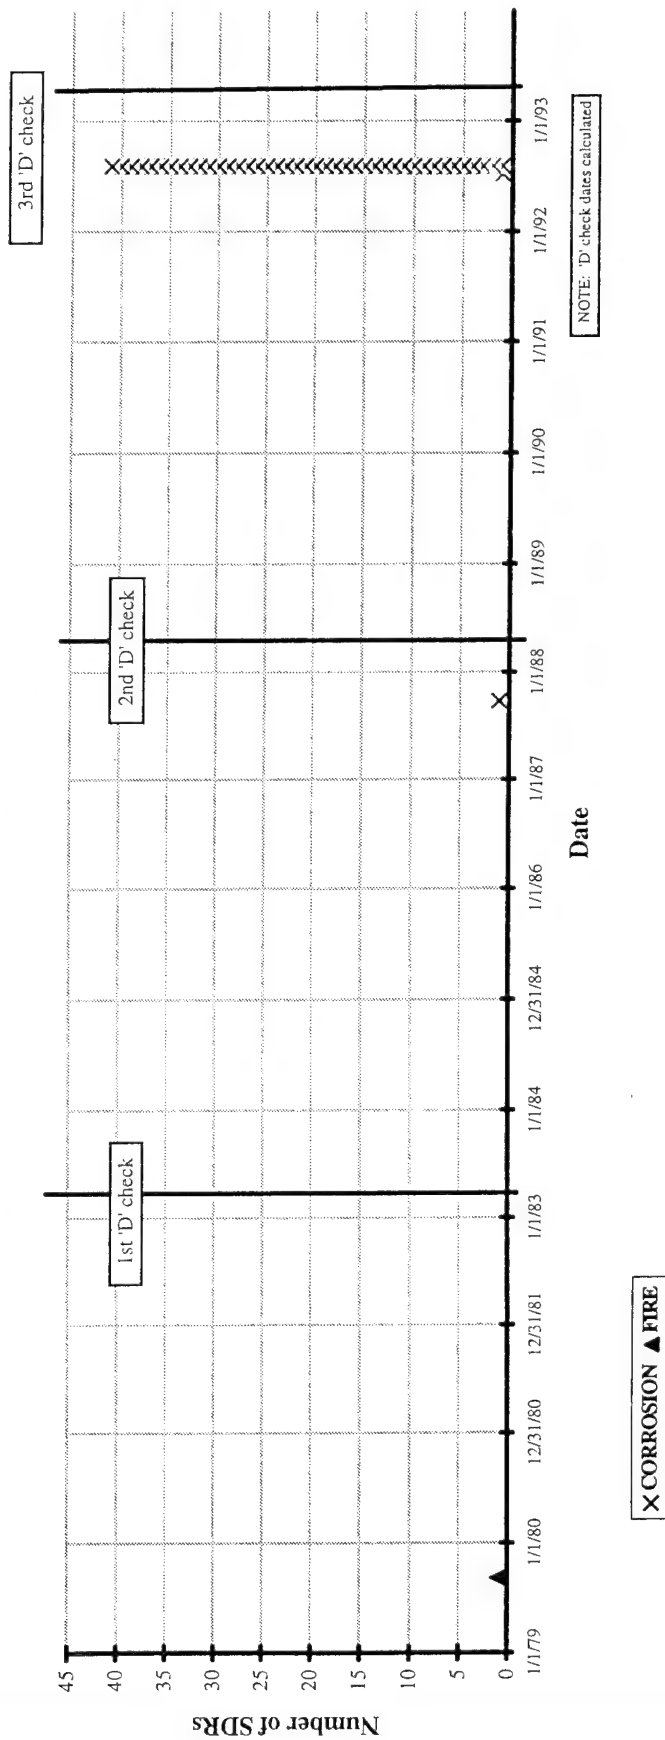
FIGURE 1. B727, S/N 21483: FREQUENCY OF CORROSION SDRs BEFORE AND AFTER A FIRE EVENT

The 727 showing the most likely fire/corrosion relationship is S/N 21483. Data shown in figure 1 shows a possible fire/corrosion relationship, a fire in 1979 followed by high corrosion events reported 13 years later in 1992. Also, the first major incidence of corrosion reporting in 1992 occurred when the aircraft was less than 15 years old.

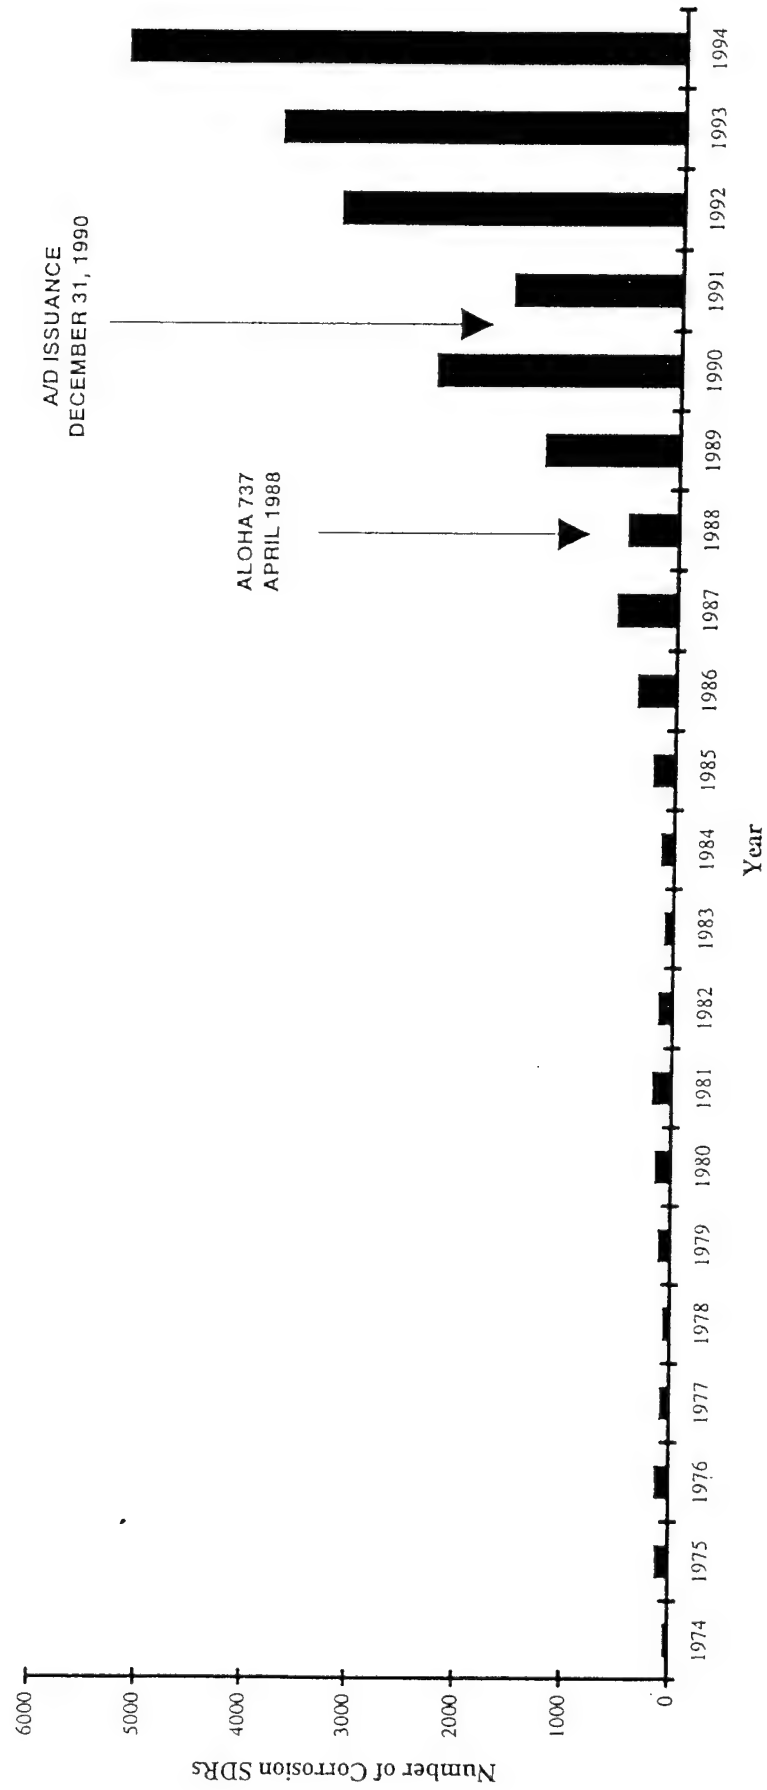
FIGURE 3. FLEETWIDE CORROSION REPORTING HISTORY FOR THE BOEING 727 AIRCRAFT

Fleetwide trends in aircraft corrosion were studied to see if aircraft with fires stand apart from overall fleet trends. It was found that on average the corrosion reporting for the 727 fleet has been low but has been increasing since 1984 when the first 727 became twenty years old. Figure 3 and table 5 illustrate this trend versus calendar time. Figure 4 highlights 1988 through 1994 and includes total fleet size and total aircraft over twenty years of age during that period. The aircraft aging trend is relatively flat and doesn't fully explain the increase in corrosion SDRs. A possible explanation as indicated on figure 4 might be increased corrosion awareness due to the Aloha incident (Boeing 737 fuselage failure) and the issuance of the Aging Aircraft Corrosion inspection ADs (table 2).

The conclusion is that when considered against the fleetwide trend in corrosion reporting, the corrosion of the fire damage aircraft cannot be attributed to fire, but is more likely due to aircraft aging and the aging aircraft inspection initiatives.

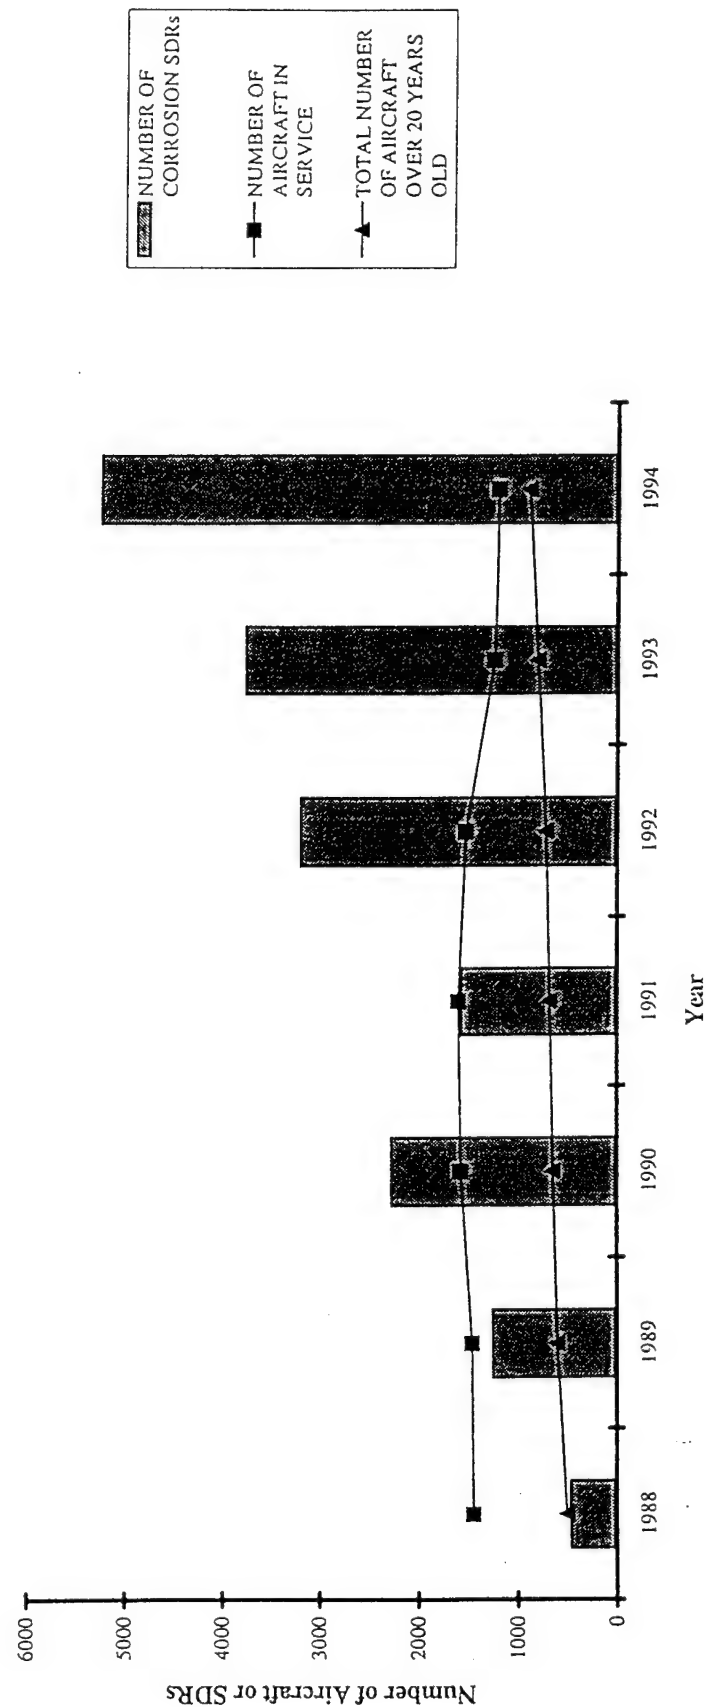
FIGURE 4. CORROSION REPORTING 1988 TO 1994 RELATED TO AIRCRAFT AGE AND FLEET SIZE, B727 AIRCRAFT

The fleet analysis showed a rise in Boeing 727 corrosion reporting beginning in 1984, the year the first aircraft turned twenty years old. The rate of aging (age 20 years) between 1984 and 1994 averaged 80 aircraft per year or approximately 6 percent of the fleet per year. Annual corrosion reporting over the same period increased from, 115 in 1984, to, 5235 during 1994. The new corrosion inspection program resulting from the Aging Aircraft Initiative is believed to have contributed to the increase after 1988.
